# 射线探伤

## 沟槽对比试块

## 符合国家NB/T47013.2-2015相关标准

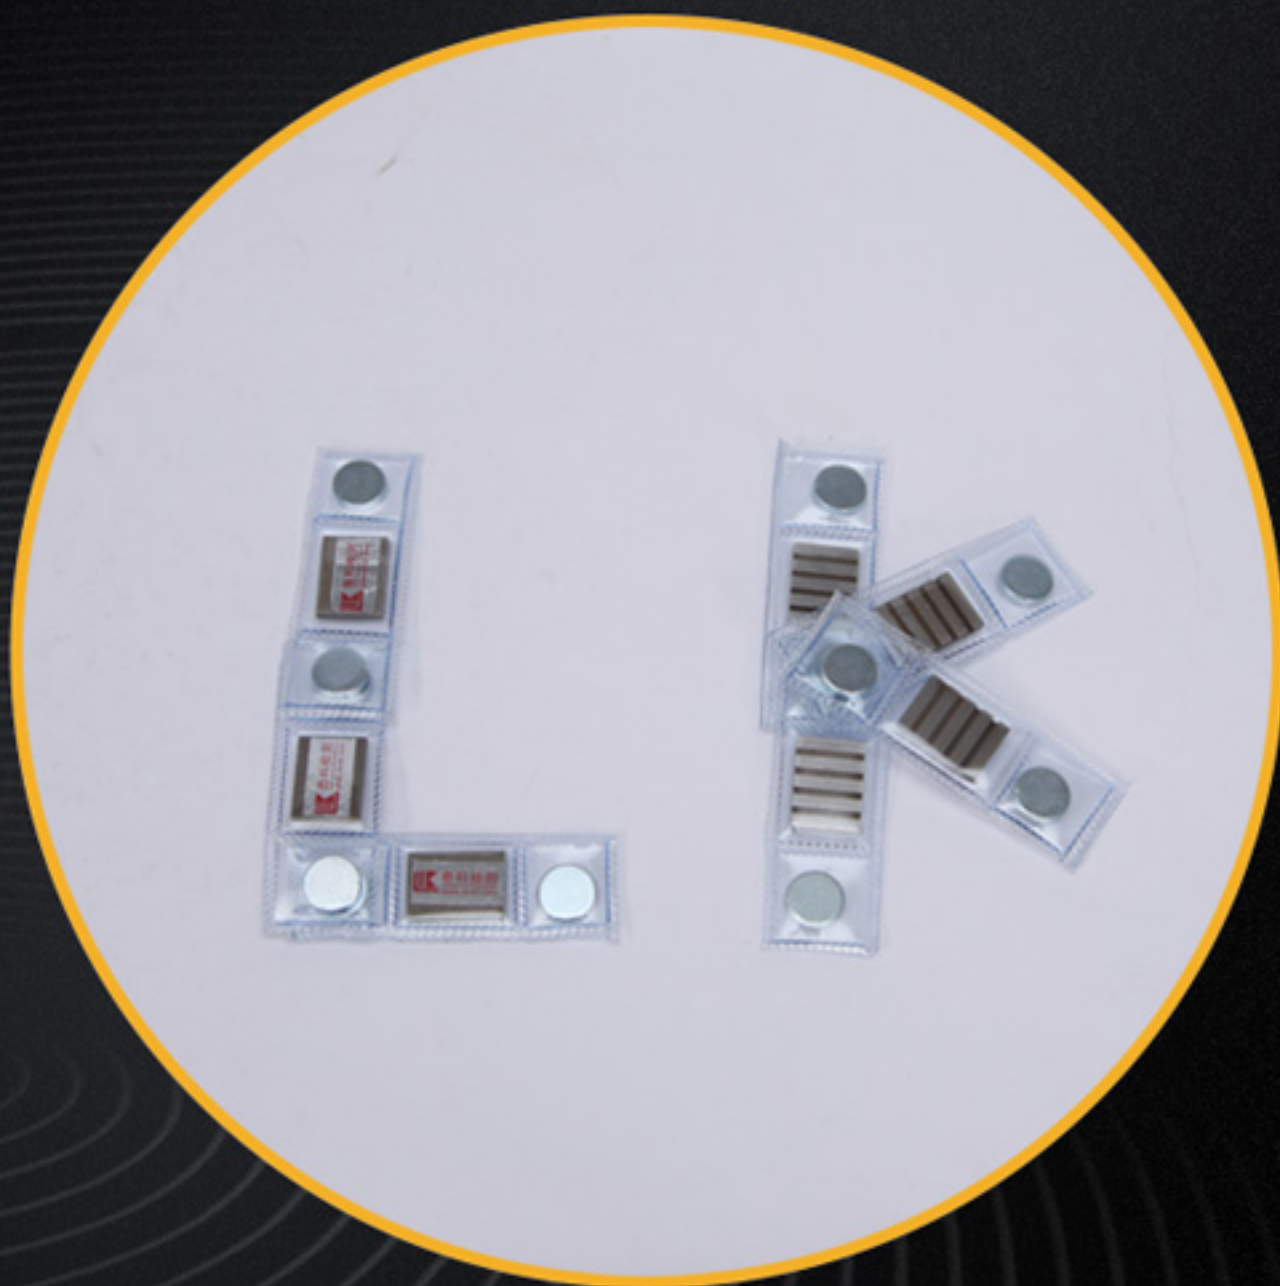
用于射线探伤时测量缺陷的深度

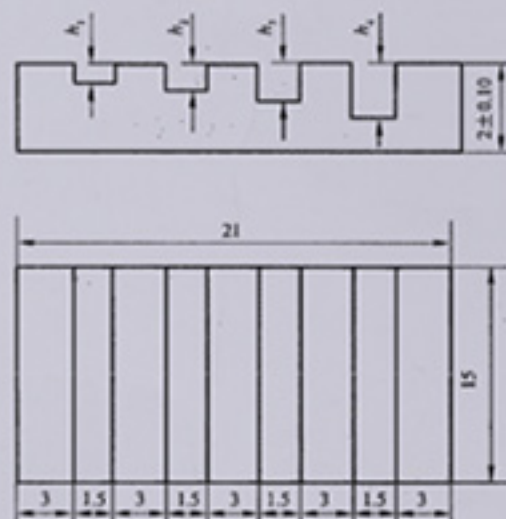
图 L.2 II型对比试块

表 L.1 II型对比试块的尺寸

| $h_1$ | $h_2$ | $h_3$ | $h_4$ | 尺寸偏差 |
| 0.3 | 0.5 | 1.0 | 1.5 | $\pm 0.05$ |
